## METHOD OF STRENGTHENING STRUCTURE OF BUILDING

### ABSTRACT

*The owner asks the author to see the condition of the commercial building. The author recognizes that Commercial Buildings do not meet the requirements of the structure of strength, stability, and stiffness. Of the substructure and upper structure of commercial buildings in the business center in Riau Province. Even though they have been built, they do not meet the structural requirements. A thorough analysis is needed from the bottom structure to the top structure. This research aim is strengthening under and upper structure, nothing moving the user and operational — survey methodology with collecting primary and secondary data. Substructure and upper structure data are analyzed for the cause of the damage. The solution is the design and construction stages — design of substructure and upper structure strengthening. The right construction stage applies for an essential role in the success of the construction because the condition of the existing structure from the bottom up is weak. The structural improvement achieved successful results*

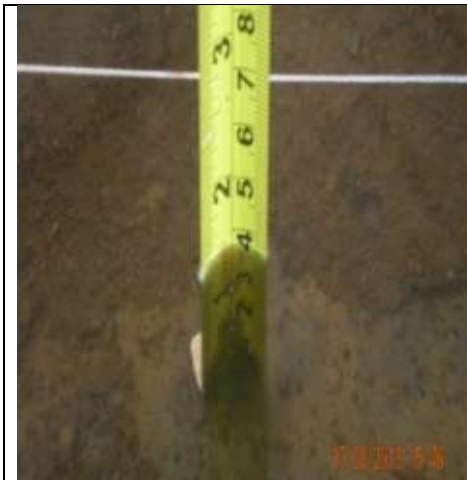
Plate Structure: broken and deflated 7cm. The reason is that the foundation is fragile, and the results of soil tests show that the carrying capacity is weak. So it is necessary to add a foundation because the building is ready so that the space for movement is limited, especially the area above. It is a 30cm diameter bore pile with a modified tool made loose, so the device enters the building, and installed in the room. The decrease in almost every basement column, even reaching 189mm (based on surveyor measurements). Because the foundation of differential settlement occurs, making the column tilted, (Triastuti, 2017) this adds a secondary moment,

Figure 1. Basement / Plate Structure: broken and deflated 7cm

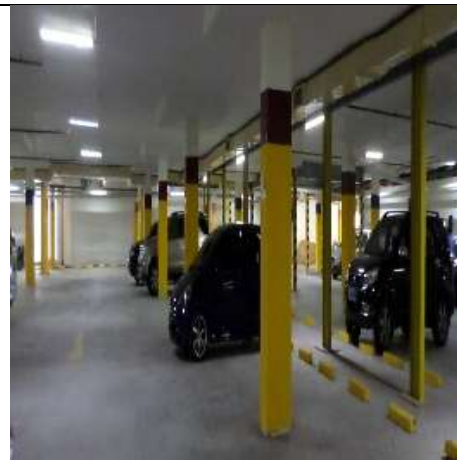
Figure 2. The decrease in almost every basement column, even reaching 189 mm (based on surveyor measurements)

All of the damage in the upper structure, the cause is a fragile foundation with little bearing capacity due to the shallow foundation of the concrete block. So it is necessary to add a 25 cm mini bore pile foundation with depth is 13m (NSPT 32).

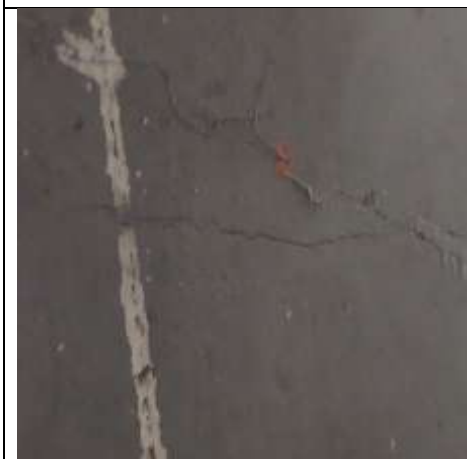
The occurrence of cracks in the span of the walls of shophouses (mostly due to tie beam structure). A foundation settlement causes the Crack. Schmertmann's Method (Hassan, 2017) differential settlement is

Figure 3. The occurrence of cracks in the span of the walls of shop houses (mostly due to tie beam structure)

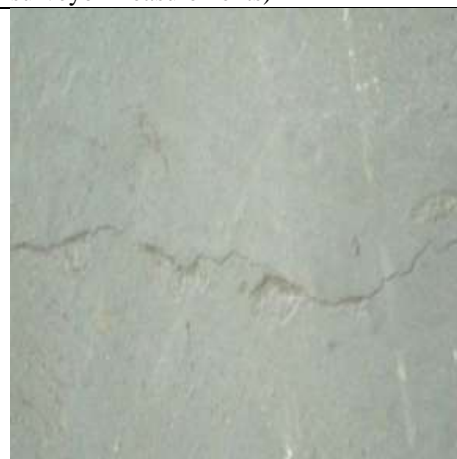
The floor has decreased (new cracks have returned to old cracks). The crack is caused by the difference in foundation settlement.

Figure 4. The floor has decreased (new cracks have returned to old cracks)

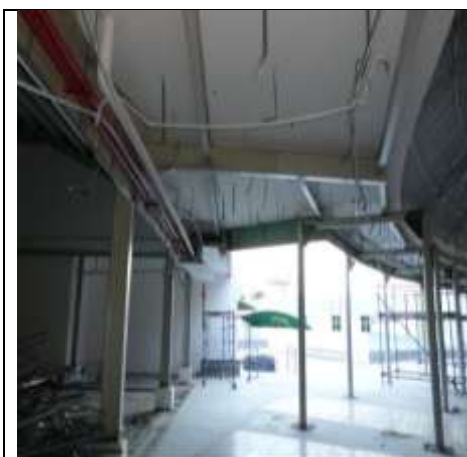
The beam is tilted and bent due to casting and settlement differences occur. The steel portal beams are bent and dented. Due to the lack of precision construction. The baseplate has no stiffener. Angkor is only at the front. The pedestal is not with stiffener. Dome always tends to expand and slide. Due to the centrifugal force of the dome with a diameter of 50 m, there is no stiffener base plate. It is not meeting the structural requirements. It can result in long-term fatigue.

Figure 5. The beam is tilted and bent

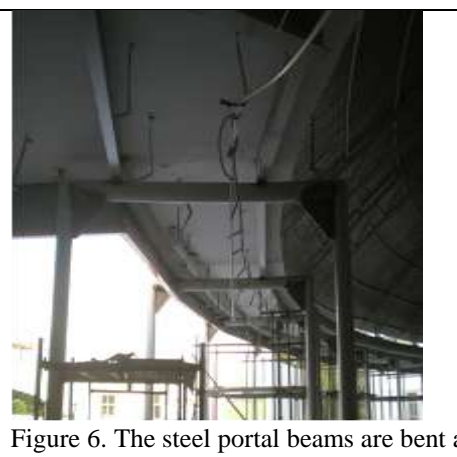
Figure 6. The steel portal beams are bent and dented

- Stiffener and 12mm round bar bracing and 25mm sling on the portal and re-welding on all connections.
- The round bar 16mm bracing on the weakest span of the dome structure.
- Steel WF 250,250.11.13.66.5 kg/m.
- Upper structure is as a pedestal dome structure.
- INP steel 400.200.9.11.56.1 kg / m, WF 100,100.9.11.17.2 kg / m, and plate 4'.8'.12mm.280 kg/sheet.
