TROUBLESHOOTING TEMPERATURE GAUGE ON CONTROL PANEL OF ENGINE 3066 AT ALAT BERAT WORKSHOP OF POLITEKNIK NEGERI JAKARTA

Abdul Azis Abdillah^{1✉}, Erifmi Zahada², Lentang B. Sibarani², Imam Wahyudi², Azwardi², Fuad Zainuri², Haidir Juna², Memed Sumatono²,
^{1,2}Alat Berat, Jurusan Teknik Mesin, Politeknik Negeri Jakarta
 ✉e-mail :abdul.azis.a@mesin.pnj.ac.id

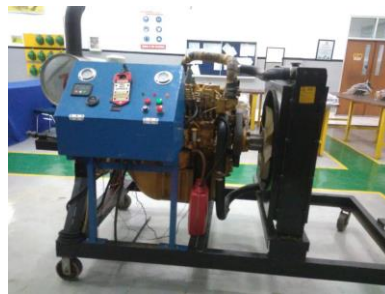
Figure 1. Current Condition of Engine 3066

The temperature gauge functions to make it easier to monitor the temperature of the coolant on the 3066 engine. Based on data from the initial test results in heavy equipment workshops [2], [3], the condition of the engine control panel 3066 (figure 1) belonging to the Jakarta State Polytechnic is currently not optimal, where there are still gauges and indicators that are not working optimally and are damaged. One of them is because the temperature gauge on the control panel

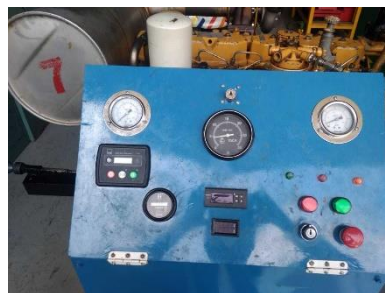
Figure 2. Control Panel of Engine 3066

1. Make sure the problem really occurs. At this stage the writer collects information related to the control panel to be worked on. Some of them are the control panel used (Figure 2), username / engine mechanic: Mr. Khaidir Juna, Prefix Engine: 7JK (Figure 3) and the problem that occurs is that the temperature gauge is not functioning (Figure 4). Where the temperature gauge has an AC220 V.

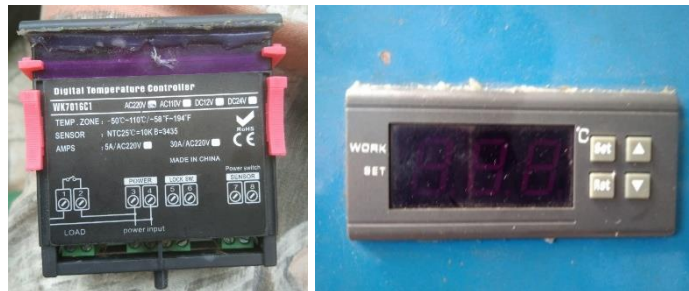
Figure 4. Temperature gauge 220ACV model on engine 3066

2020, the temperature gauge turned off and emitted smoke in the gauge section.

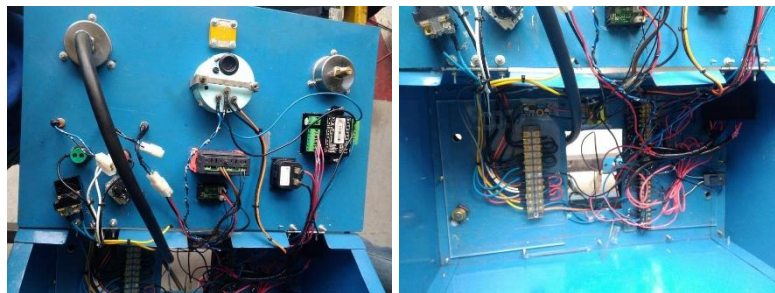
Figure 5. Visual state of the cables on the control panel

The Visual Temperature Gauge condition can be seen in table 2. Visually the 3066 engine is still good and safe for running or for practicing in heavy equipment workshops. Visually looking at the shape of each gauge and indicator on the panel, there are no significant problems found. The cables (figure 5) on the panel were not damaged, such as burns.

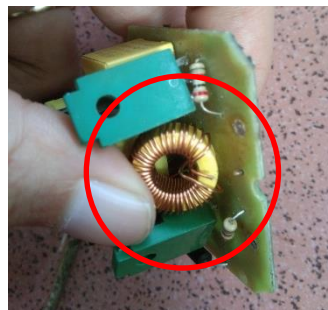
Figure 6. Condition of Step Up Transformer

- a. The cable has a short circuit
- b. Step up transformer is damaged (picture 6)
- c. Step down is damaged where the cable connection is loose (Figure 7)
- d. The temperature gauge is not working
- e. Temperature sender not working

Based on the results of the tests that have been carried out, the results obtained are that there is no output on the step-up transformer due to the breakdown of the coil in the step up transformer, so the temperature gauge cannot function properly. The cause of the problem that occurs in the step up transformer is human error due to incorrect use of the battery while running which causes a very large incoming current and damages the coil. The voltage that goes to the step up and step down transformers is in the form of AC voltage coming from the alternator. And the cause of the problem in the step down is because the age of the step down is very long and is used continuously. In addition, it was also found negligence in connecting the cable using a solder so that the variable resistor was leaking which resulted in a short step down.

- a. Damage to the step up transformer is caused by the use of a battery with a CCA (Cold Cranking Ampere) capacity of 1000. At step up the amount of current needed is 4 A, if the incoming current is excessive, the coil will break because it cannot flow more than the required capacity. Meanwhile, the step down is damaged due to errors in Man or human error. At the time of wiring the output, solder on the variable resistor part made of plastic. The variable resistor functions to regulate how many limits the voltage drop in step down. Inside the variable resistor there is a liquid which when it leaks and other components are exposed to the liquid when the voltage is applied, the component will short and be damaged.
- b. If the error occurs after testing or a new problem appears, perform the troubleshooting steps again.

After testing, information was obtained that the damage was in the step up and step down transformers. So that a new temperature gauge was purchased with a power input of 12 VDC so as not to use a step-up transformer anymore. For step down, a new purchase is made so that it can be used to reduce the voltage to be sent to the temperature gauge.
