## METHOD OF STRENGTHENING STRUCTURE OF BUILDING

### ABSTRACT

*The owner asks the author to see the condition of the commercial building. The author recognizes that Commercial Buildings do not meet the requirements of the structure of strength, stability, and stiffness. Of the substructure and upper structure of commercial buildings in the business center in Riau Province. Even though they have been built, they do not meet the structural requirements. A thorough analysis is needed from the bottom structure to the top structure. This research aim is strengthening under and upper structure, nothing moving the user and operational — survey methodology with collecting primary and secondary data. Substructure and upper structure data are analyzed for the cause of the damage. The solution is the design and construction stages — design of substructure and upper structure strengthening. The right construction stage applies for an essential role in the success of the construction because the condition of the existing structure from the bottom up is weak. The structural improvement achieved successful results*

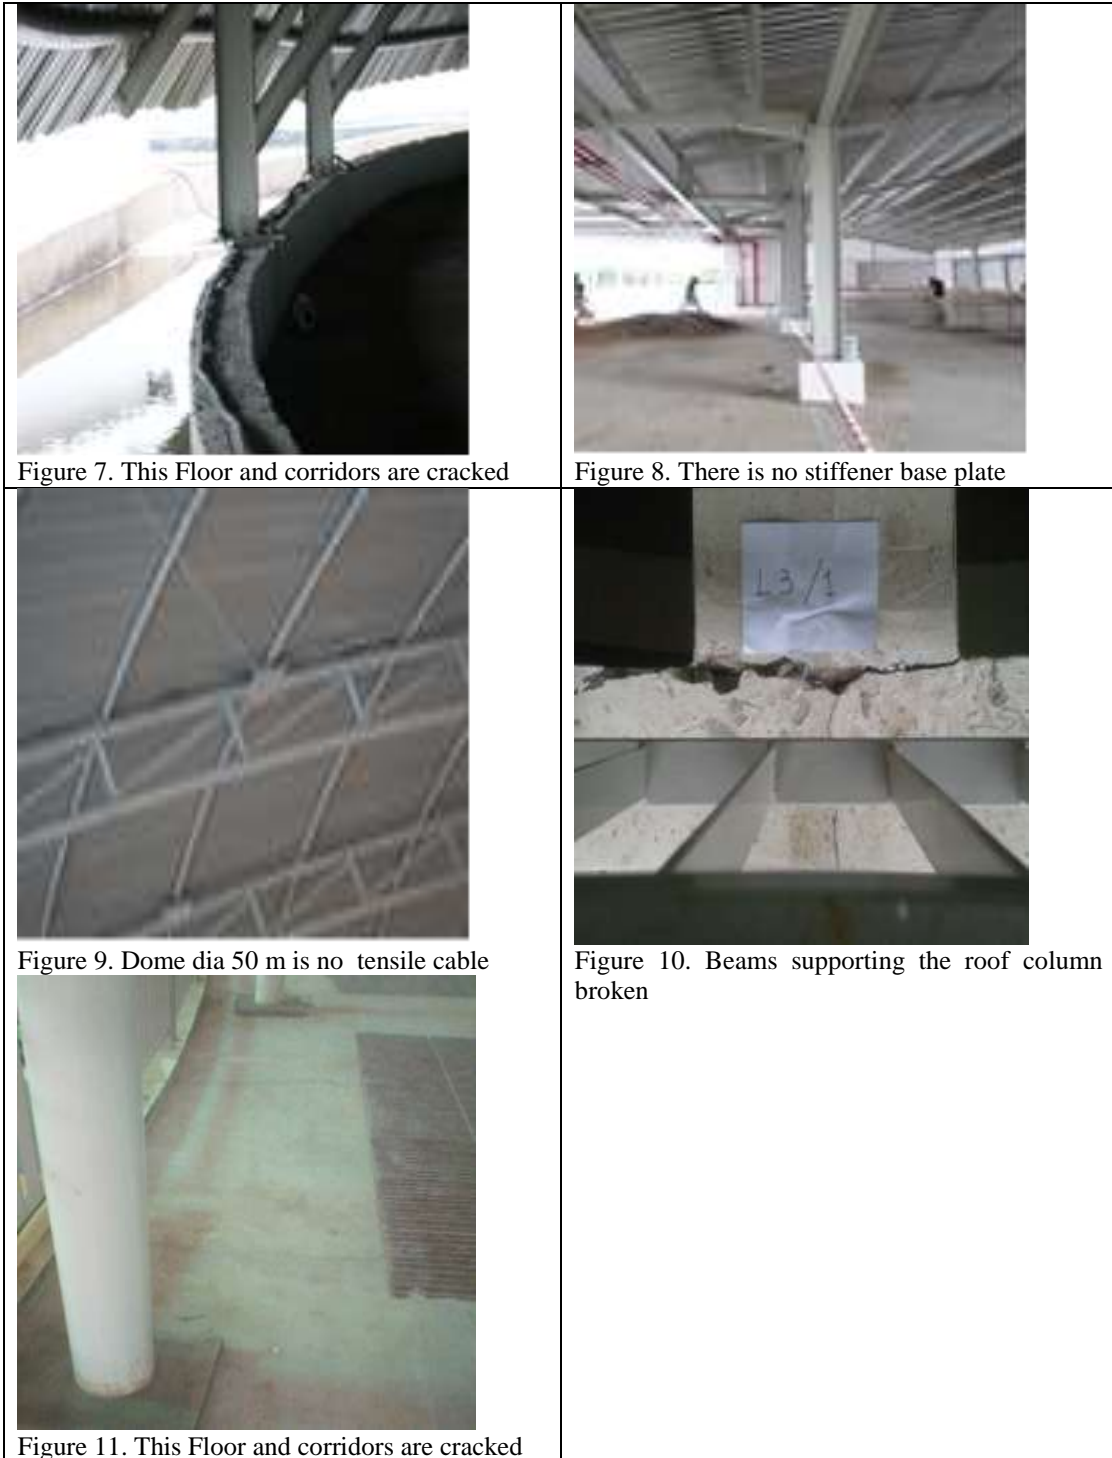
The beam is tilted and bent due to casting and settlement differences occur. The steel portal beams are bent and dented. Due to the lack of precision construction. The baseplate has no stiffener. Angkor is only at the front. The pedestal is not with stiffener. Dome always tends to expand and slide. Due to the centrifugal force of the dome with a diameter of 50 m, there is no stiffener base plate. It is not meeting the structural requirements. It can result in long-term fatigue.

Figure 6. The steel portal beams are bent and dented
